Manhole Inspection Summary

Manhole # S51A__032MH

Location Address: **rear 2718 jefferson st**

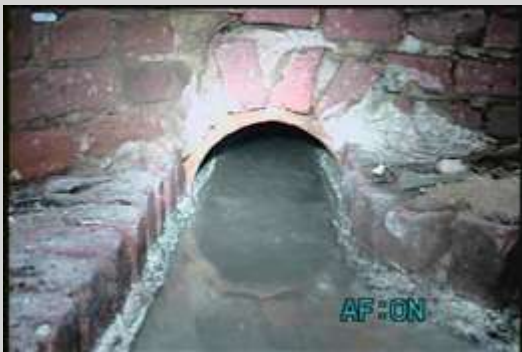
12 O'Clock Outflow

8 in. Circular Gravity Sewer
Pipe Out @ 12 O'Clock

Pipe Material: **Clay** ☐ Pipe Lined

Invert Depth: **5.93** (ft.) Flow Characteristics: **Slow**

Deposits: ☒ None ☐ Mud ☐ Sludge ☐ Debris ☐ Grease

Infiltration: **None** Pipe Seal Cond: **Unknown**

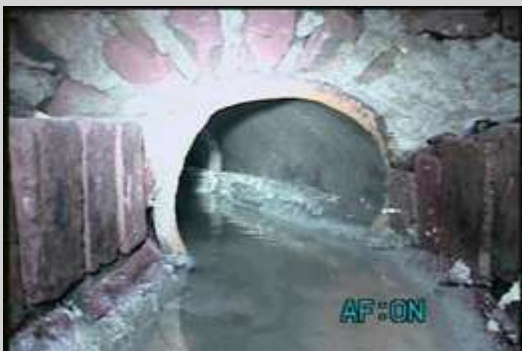
4 O'Clock Inflow

8 in. Circular Gravity Sewer
Pipe In @ 4 O'Clock

Pipe Material: **Clay** ☐ Pipe Lined

Invert Depth: **5.89** (ft.) Flow Characteristics: **Slow**

Deposits: ☒ None ☐ Mud ☐ Sludge ☐ Debris ☐ Grease

Infiltration: **None** Pipe Seal Cond: **Unknown**

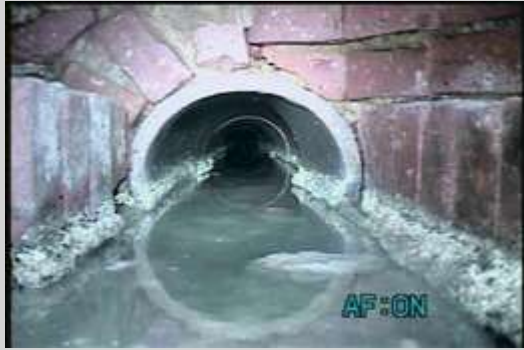
6 O'Clock Inflow

8 in. Circular Gravity Sewer
Pipe In @ 6 O'Clock

Pipe Material: **Clay** ☐ Pipe Lined

Infiltration: **None**
